Armstrong Chicken Farms Clean Water Act inspection (41 of 88 photos total)  
All photos taken by Kristine Karlson, EPA, on March 26, 2014.

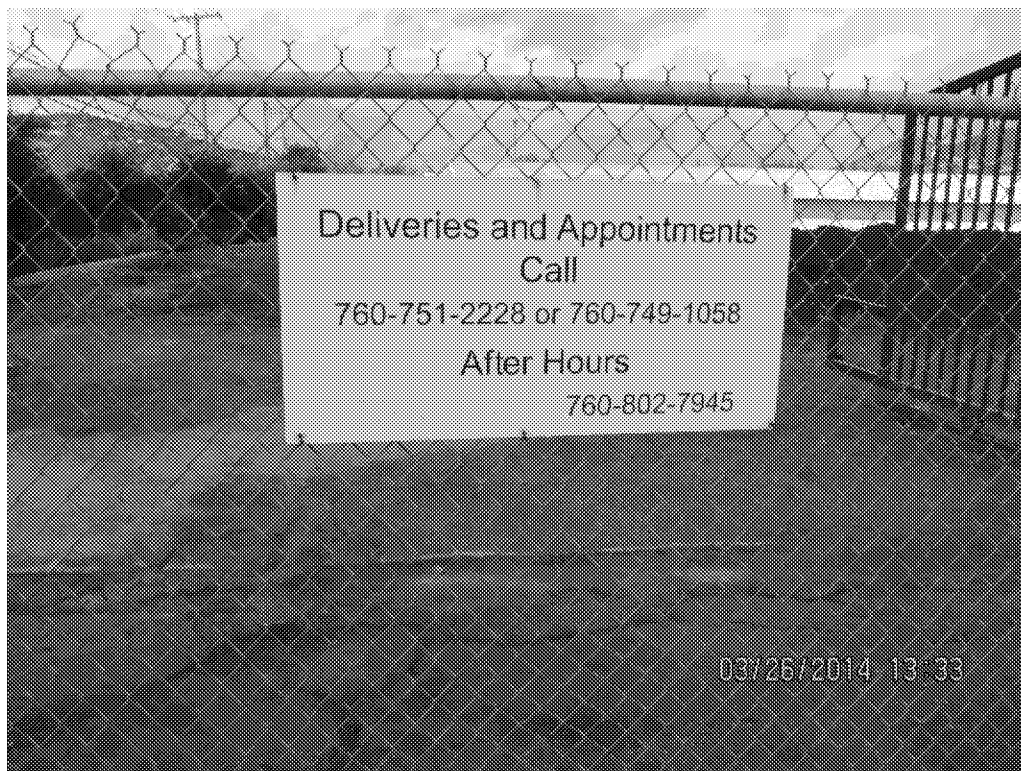
Photo 1 – Sign at entry of Armstrong Egg Farms facility located at 27023 N Lake Wohlford Rd in Valley Center, CA.

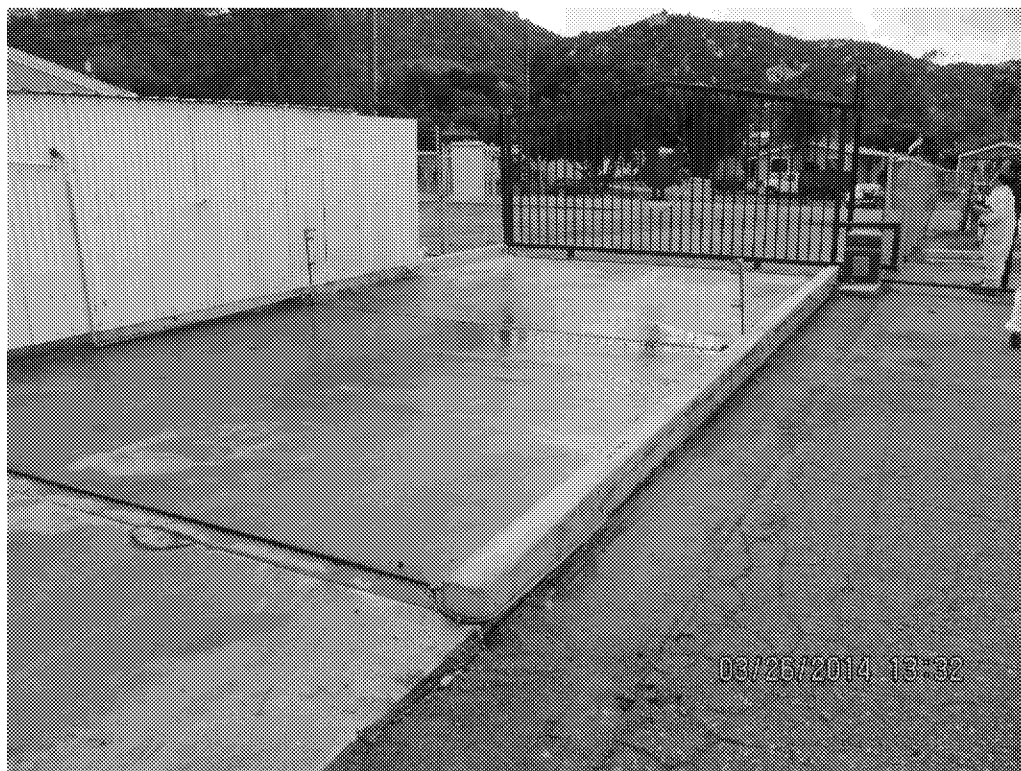
Photo 2 – View of vehicle wheel wash at facility entrance. Wash water sprays tires and is collected in an underground sump.

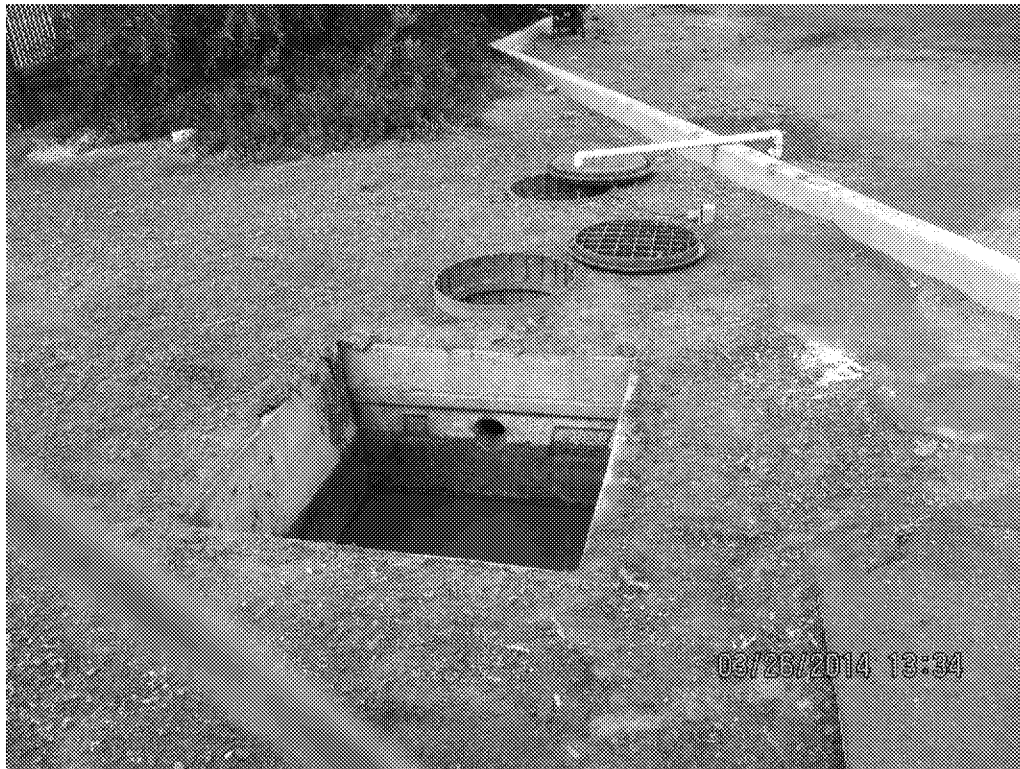
Photo 3 – View inside sump where wheel wash water is collected and reused. At the time we arrived, a vacuor truck was cleaning out the sump.

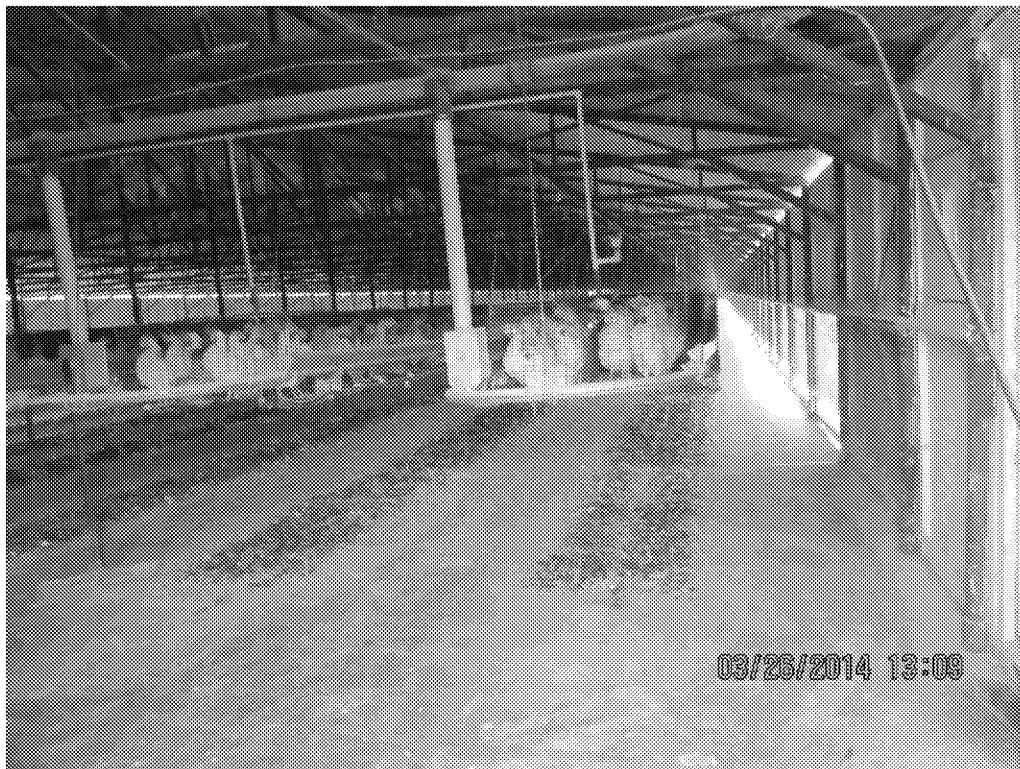
Photo 4 – View inside one of the hen houses. Manure falls to the floor and is scraped out by workers.

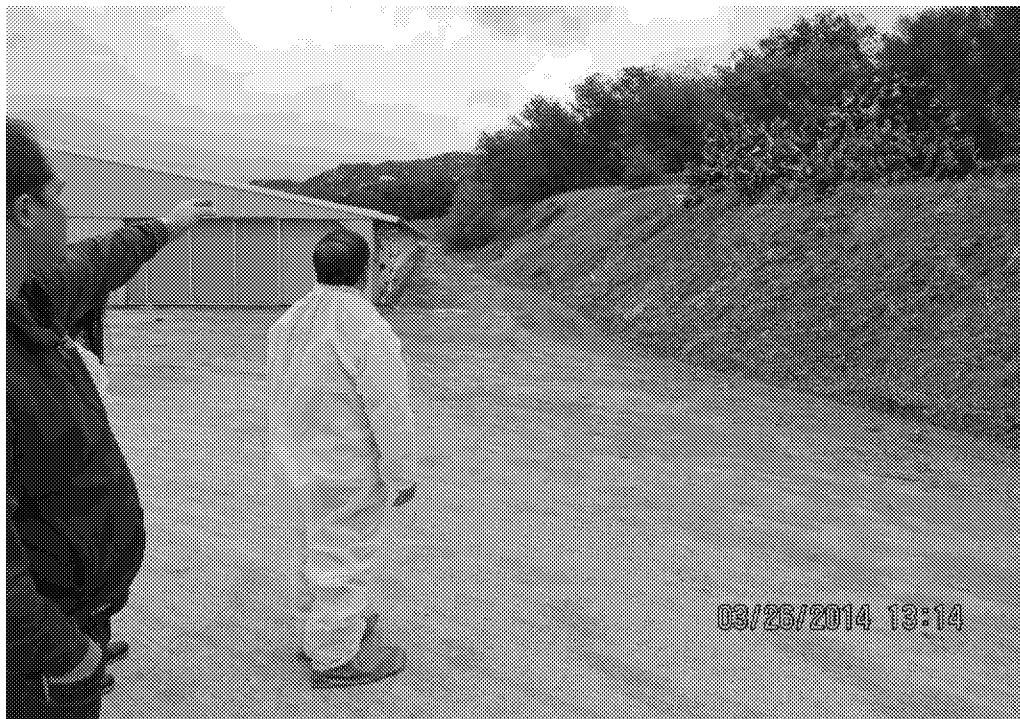
Photo 8 – View of the easternmost hen house adjacent to the canal in the previous photo. The earthen berm supports the western side of the canal. The bed of the canal lies above the level of the ground below.

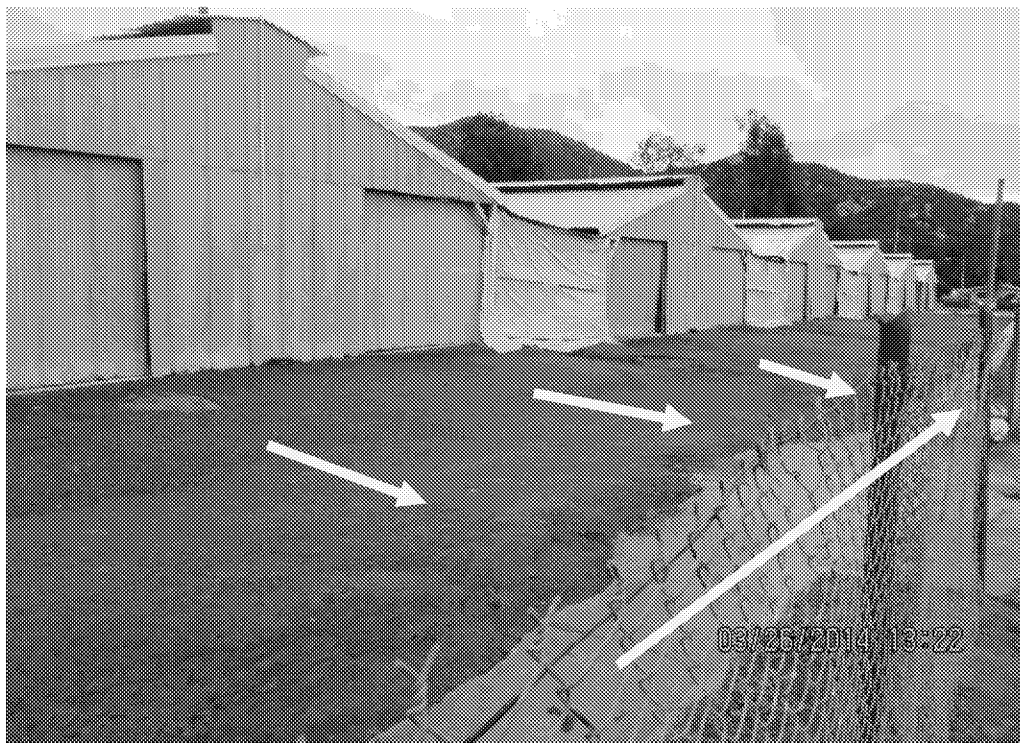
Photo 9 – Hen houses lined up in the southern portion of the facility. Arrows mark the likely direction of any stormwater flows, based on our observations of the topography and the operator's statements. Flow is downhill to the north, then west toward the roadway.

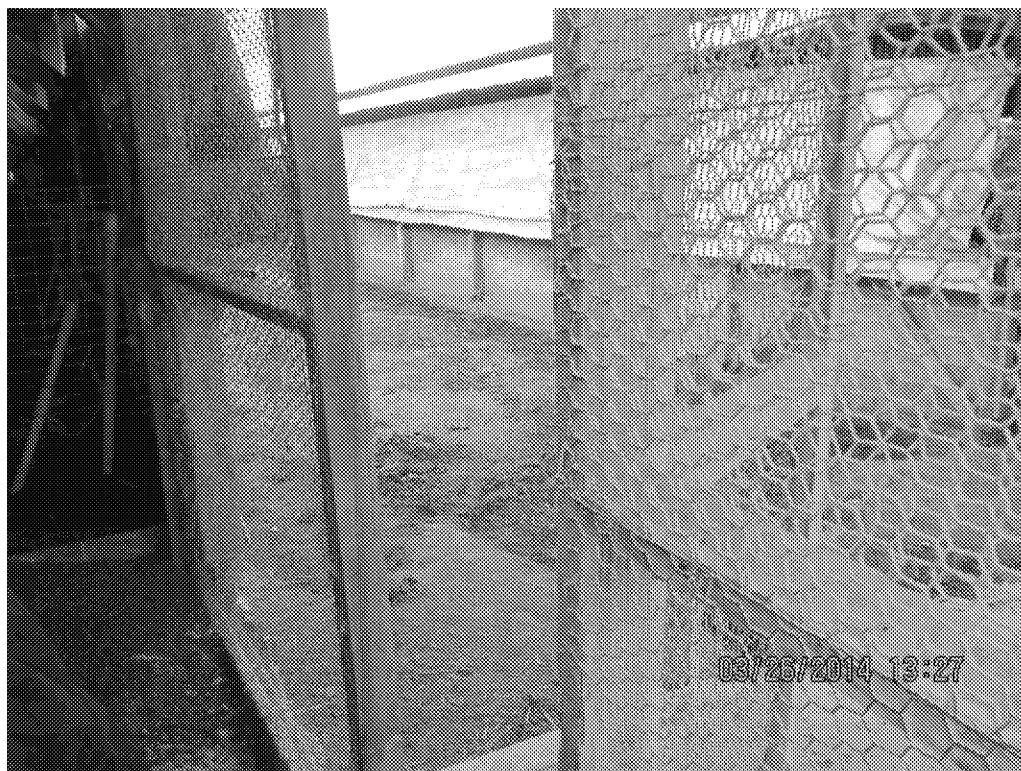
Photo 10 – View of the area between two of the hen houses in the previous photograph. Each of these areas discharges via a small culvert to the paved area immediately north. There did not appear to be much, if any, waste (feathers or manure) accumulated in these areas.

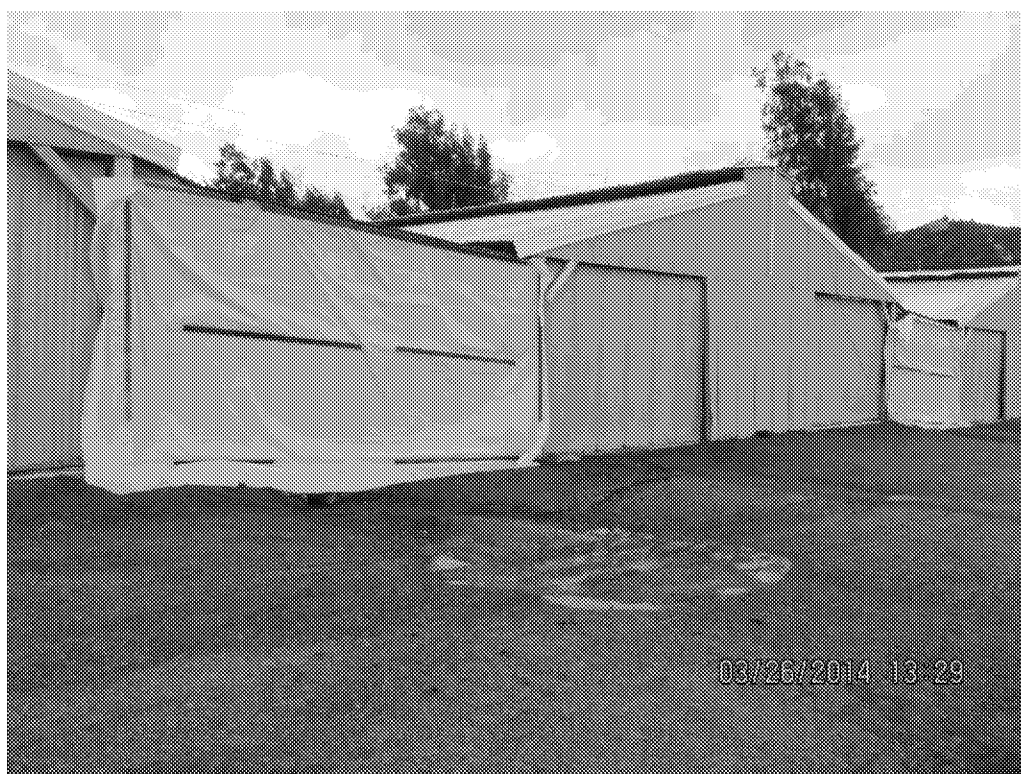
Photo 11 – View of one of the small culverts between the hen houses in photograph 9.

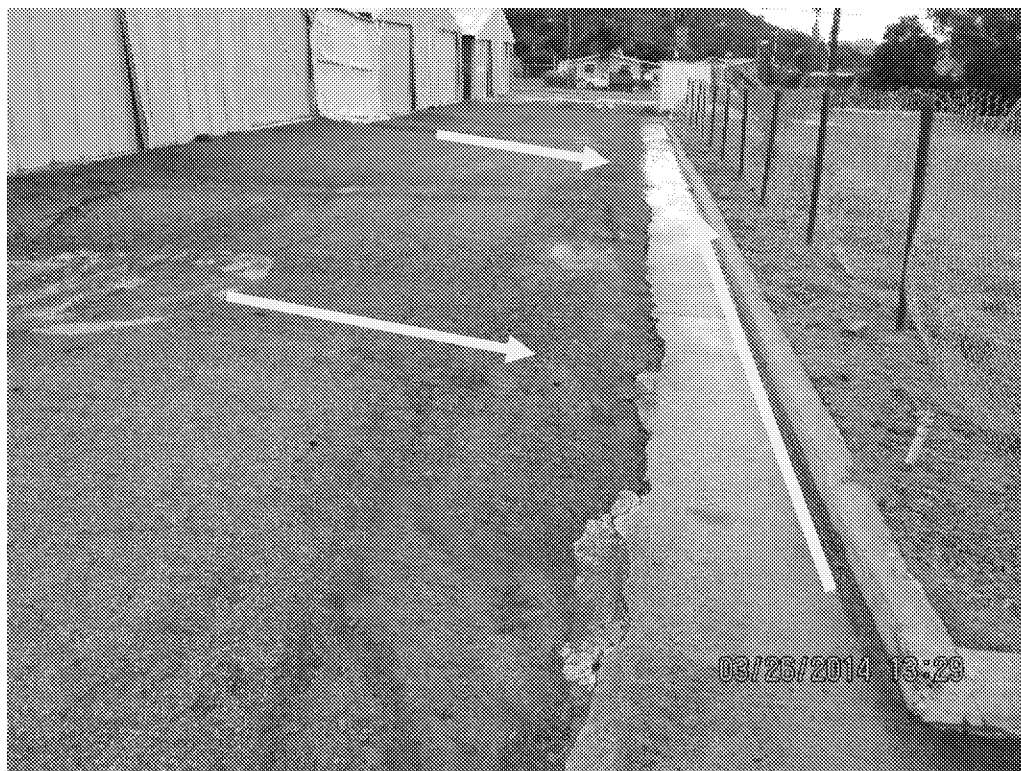
Photo 12 – Looking west along the curb in front of the hen houses in photos 9-11. Arrows show the direction of flow.

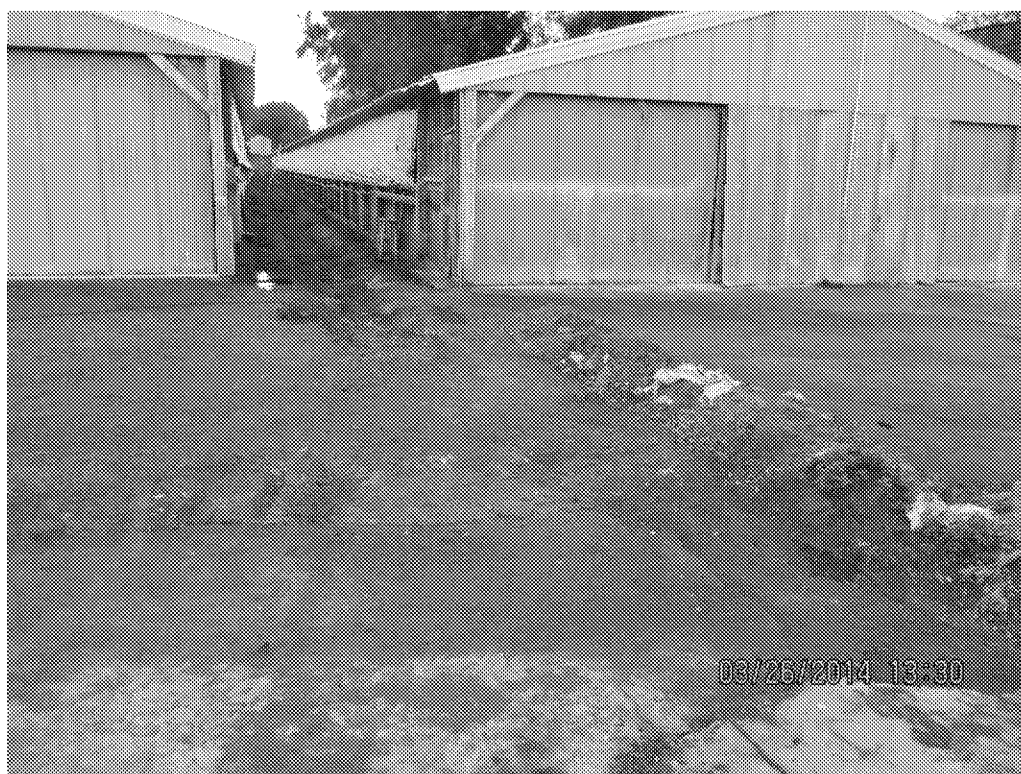
Photo 13 – Area between two hen houses graded to discharge in front of earthen berm. The berm can also be seen at the top of the previous photo.

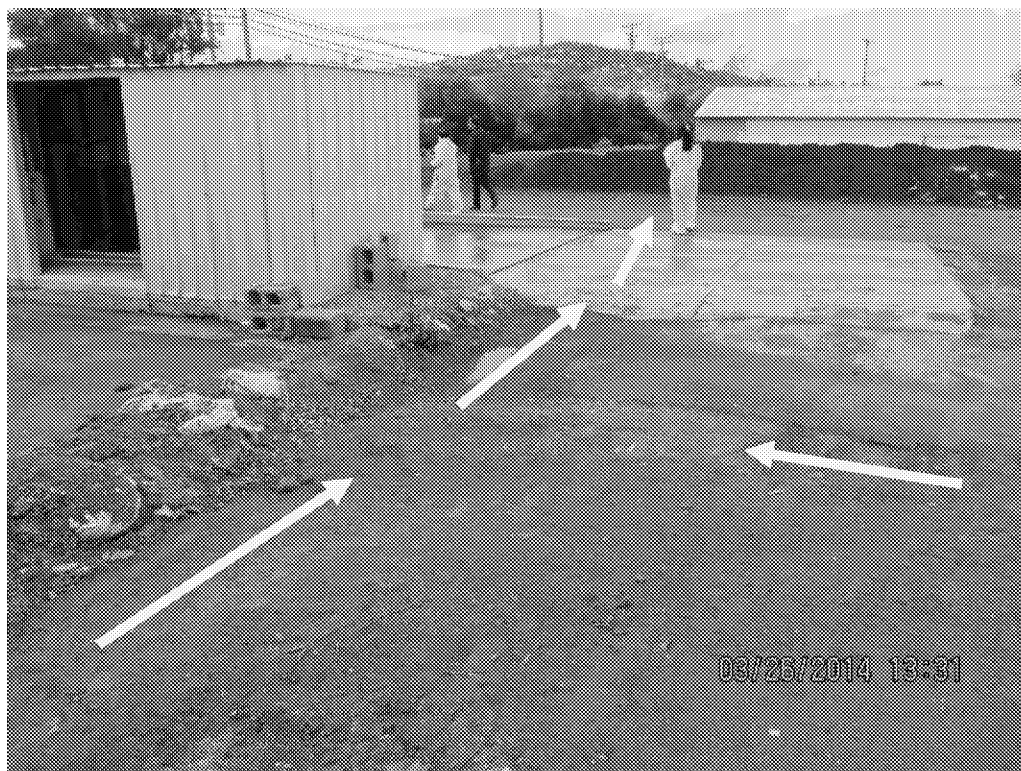
Photo 14 – View toward the northwest of the same earthen berm. It directs any flows from the hen houses in the south end of the facility across the pavement and toward the manure piles (see arrows).

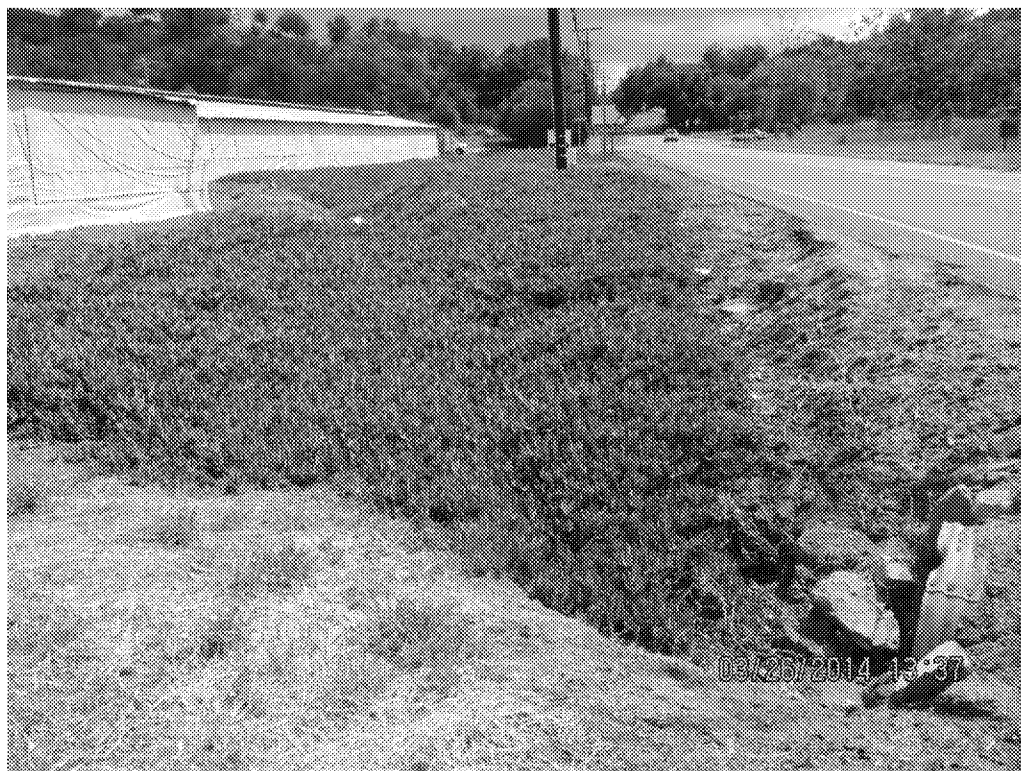
Photo 15 – Ditch running along the west side of the southernmost hen houses. The culvert carries flows westbound, under North Lake Wohlford Rd.

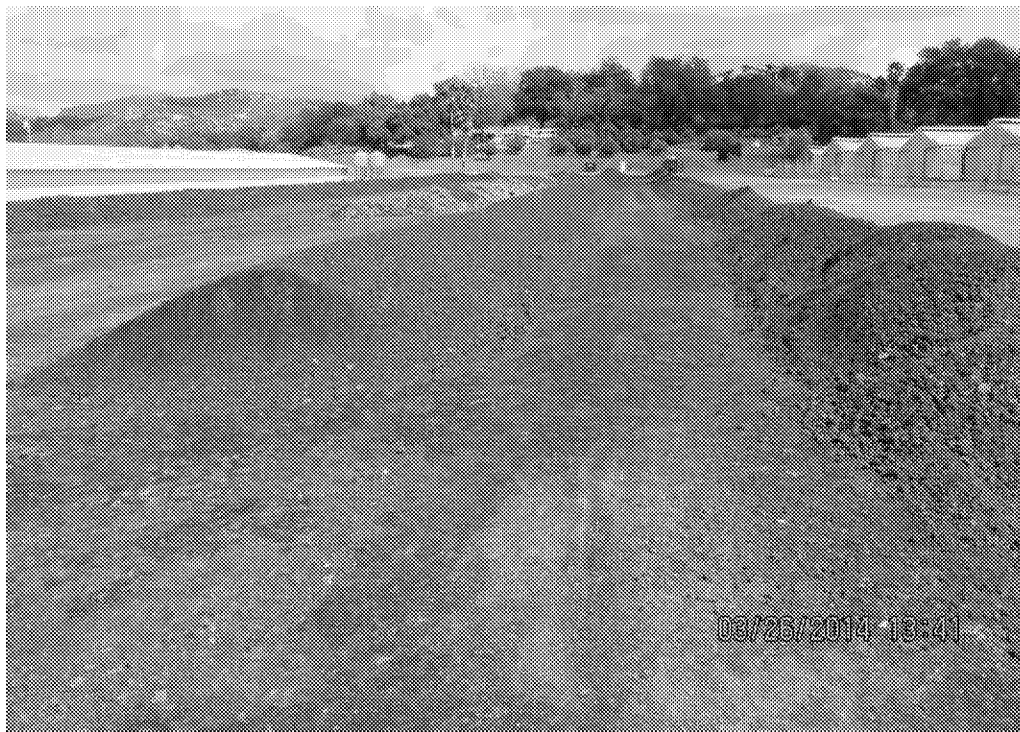
Photo 16 – Closer view of the manure piles stored in the center of the site. These were previously shown in Photos 5, 6 and 14.

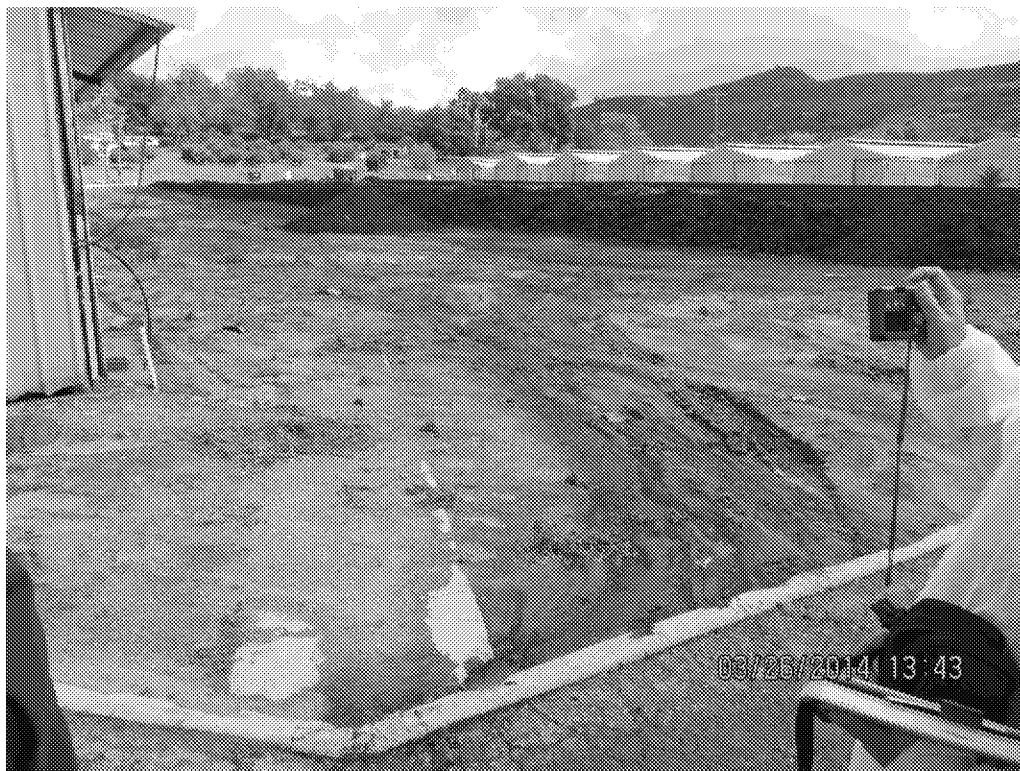
Photo 17 – This unpaved area to the north of the manure piles contains manure runoff rills. The rills and topography show that the direction of the runoff is to the northwest, and then back onto the paved area along the western border of the facility.

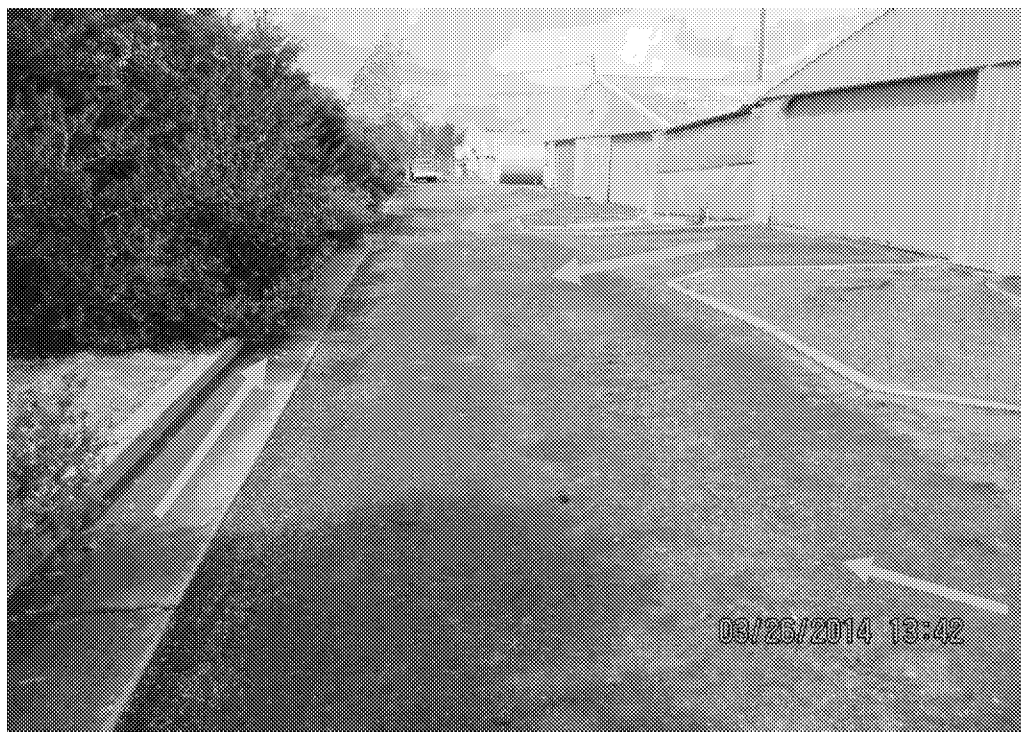
Photo 18 – View toward the north along the paved western border of the facility. According to Mr. Armstrong, the curb to the left keeps flows moving toward the discharge point near the NW corner. Arrows show reported direction of flow.

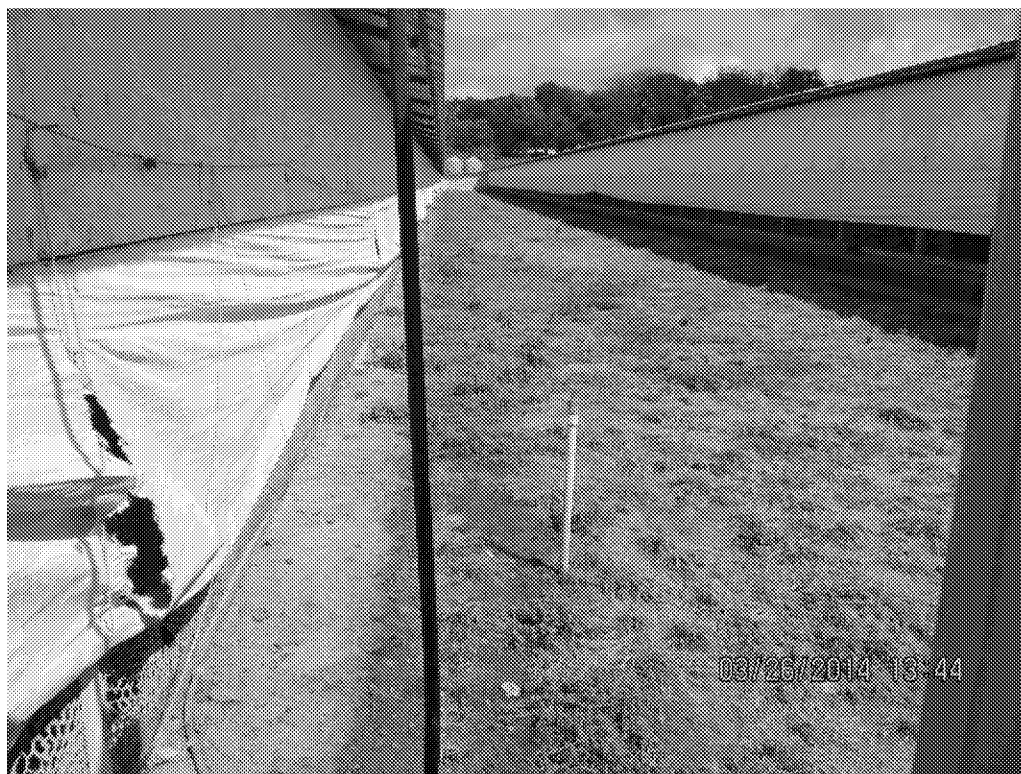
Photo 19 – View of the area between hen houses in the northwest quadrant of the facility.

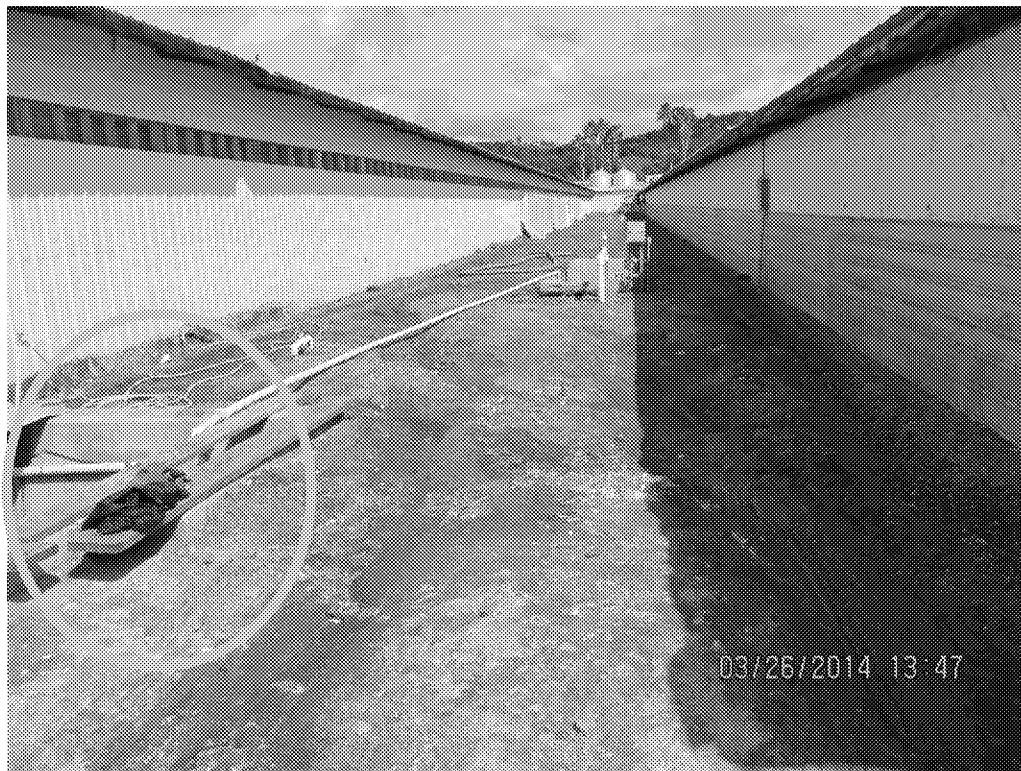
Photo 20 – View between the last two hen houses in the northwest quadrant of the facility. Areas are eroding, and there are feathers on the ground. On the left (marked) is a manure cleanout.

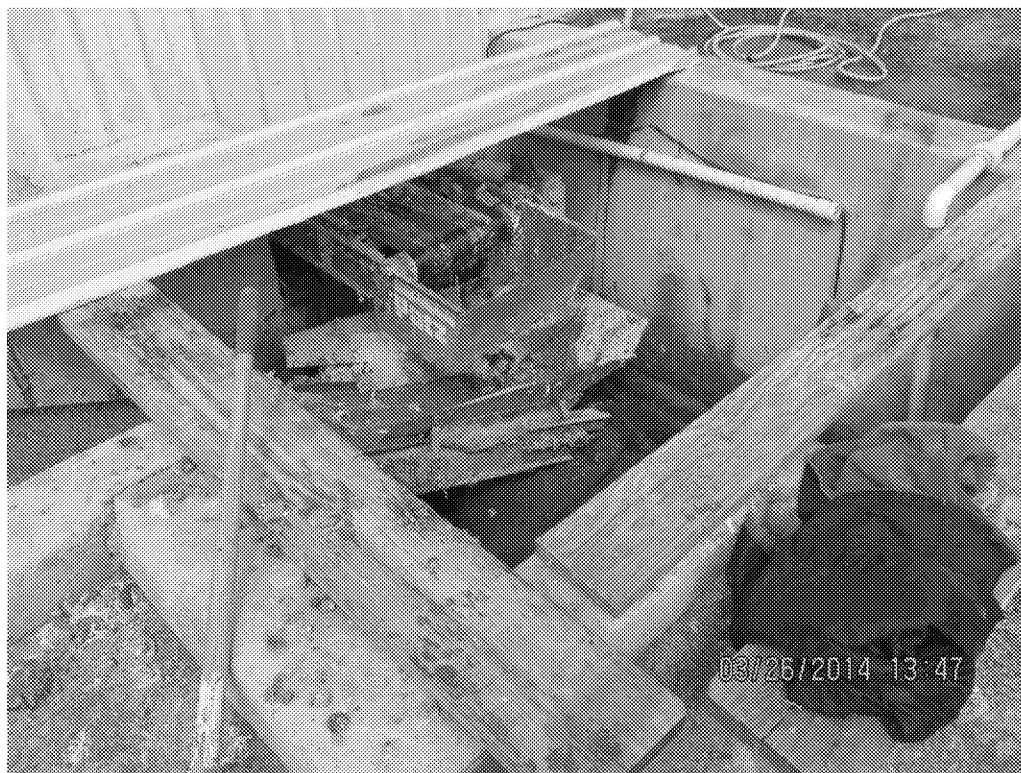
Photo 21 – Closer view of manure cleanout in previous photo.

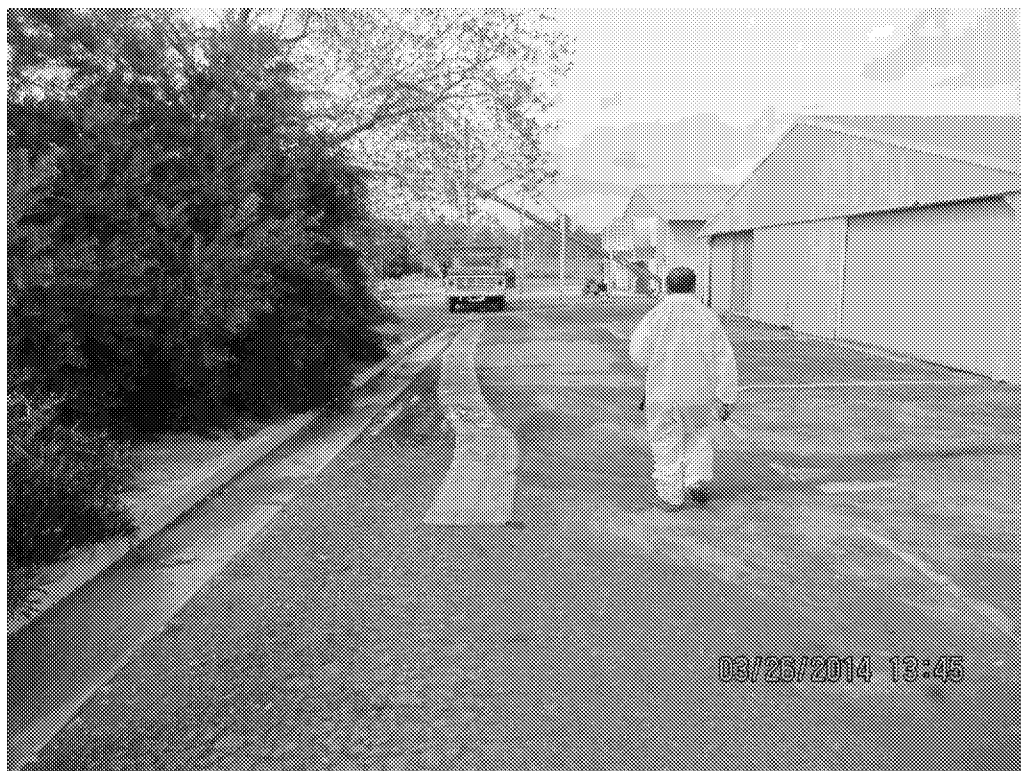
Photo 22 – Toward the end of the curb seen in Photo 18. Ahead, a blue conveyor belt is visible, loading manure from the cleanout in Photos 20 and 21 into the back of the red truck.

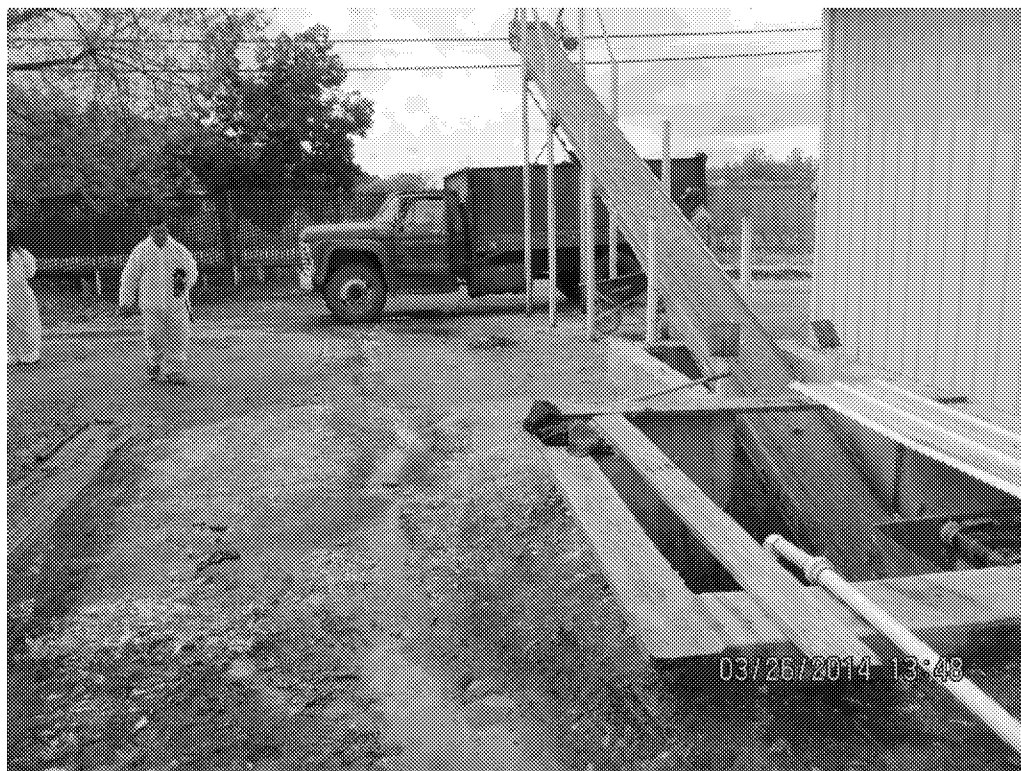
Photo 23 – View of conveyor belt unloading manure into the red truck in Photo 22. Manure is spilled on the pavement.

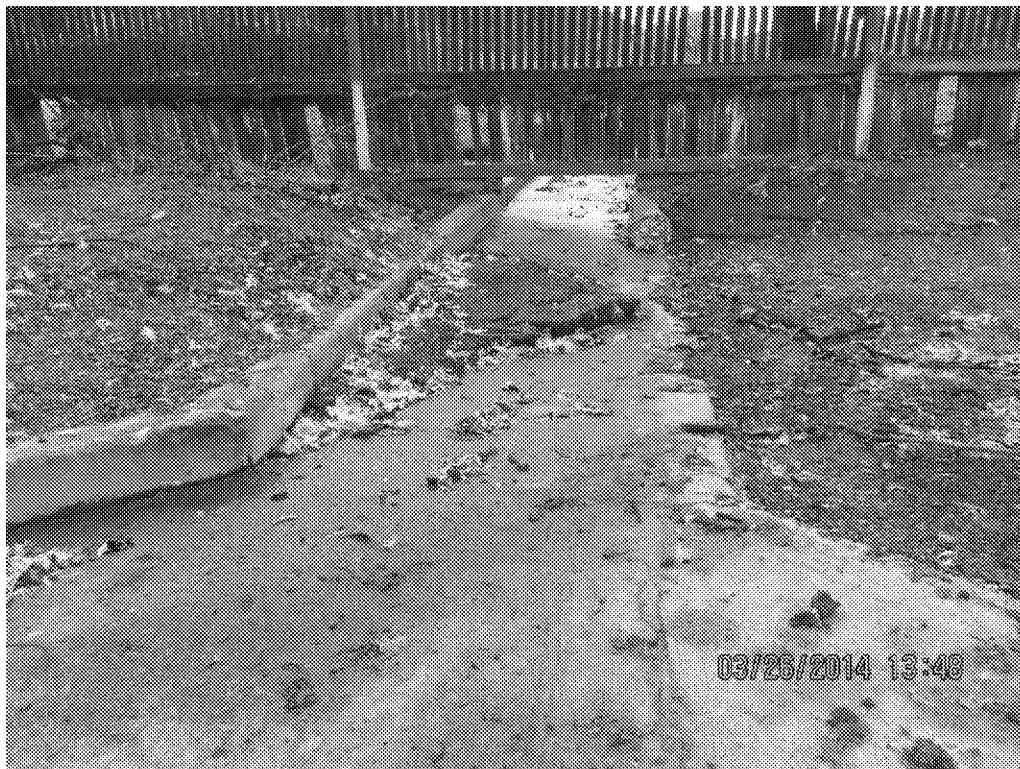
Photo 25 – Closer view of discharge point seen in previous photo. A cement channel leads under the fence line to the west. Feathers and other debris has accumulated here.

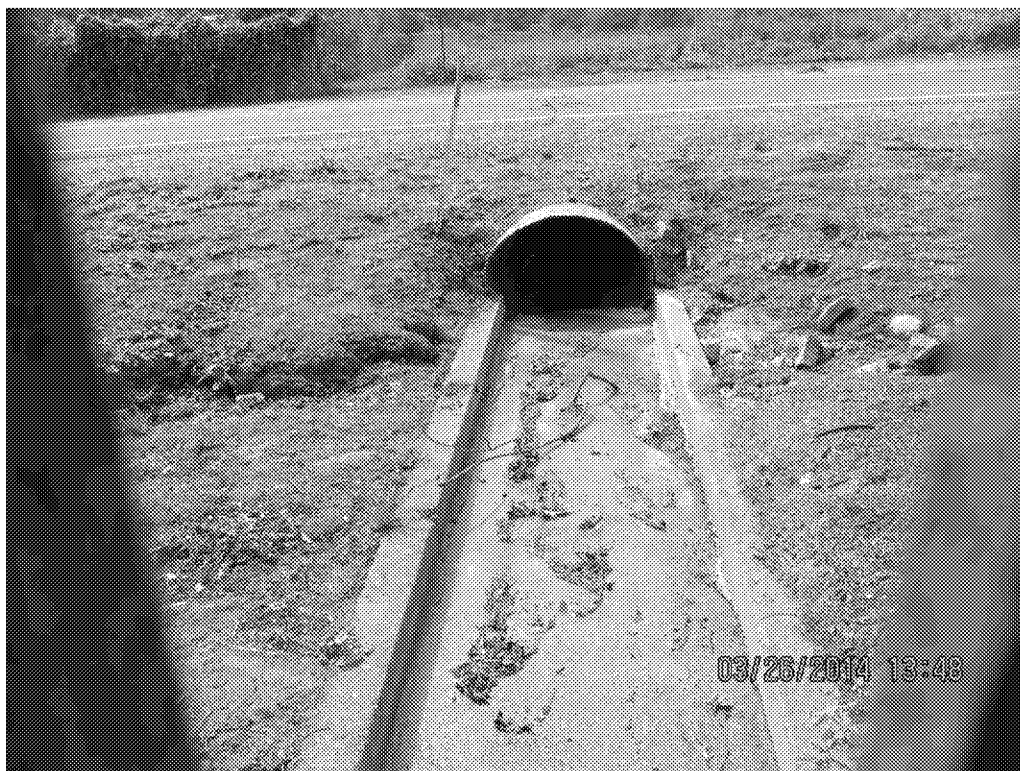
Photo 26 – View through the fence of the cement channel, as it enters a culvert that crosses under North Lake Wohlford Rd.

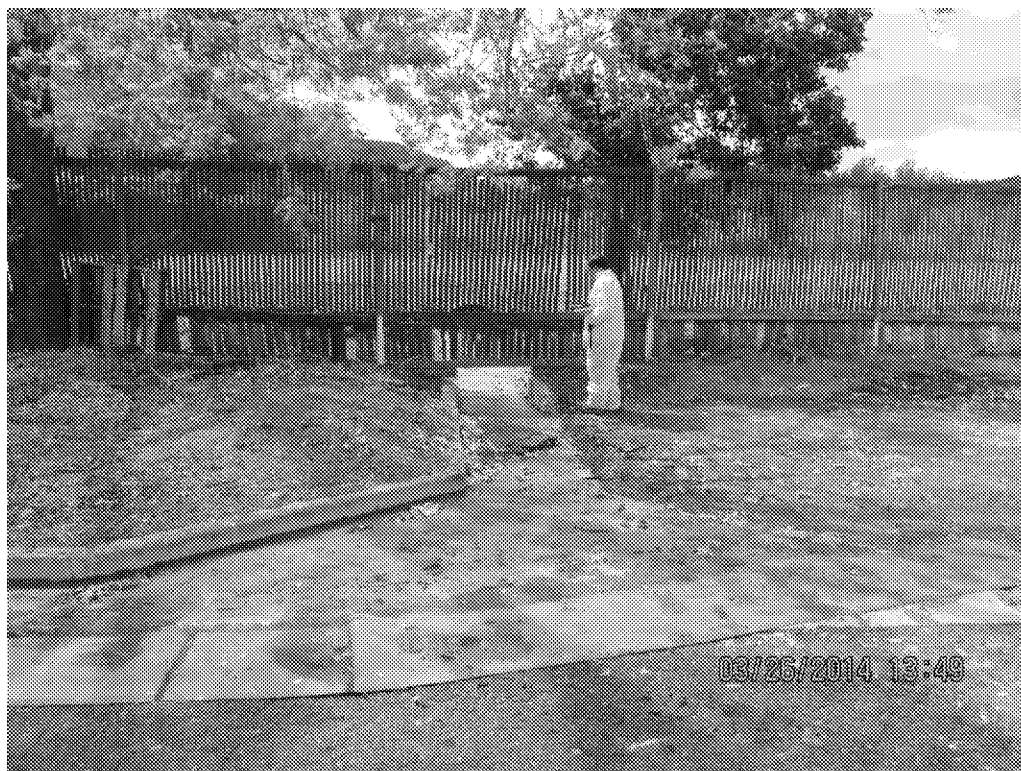
Photo 27 – Wider view of the discharge point. Mr. Armstrong said that this area is slated to become a retention pond (to prevent discharges), per an engineering plan drafted in 2011.

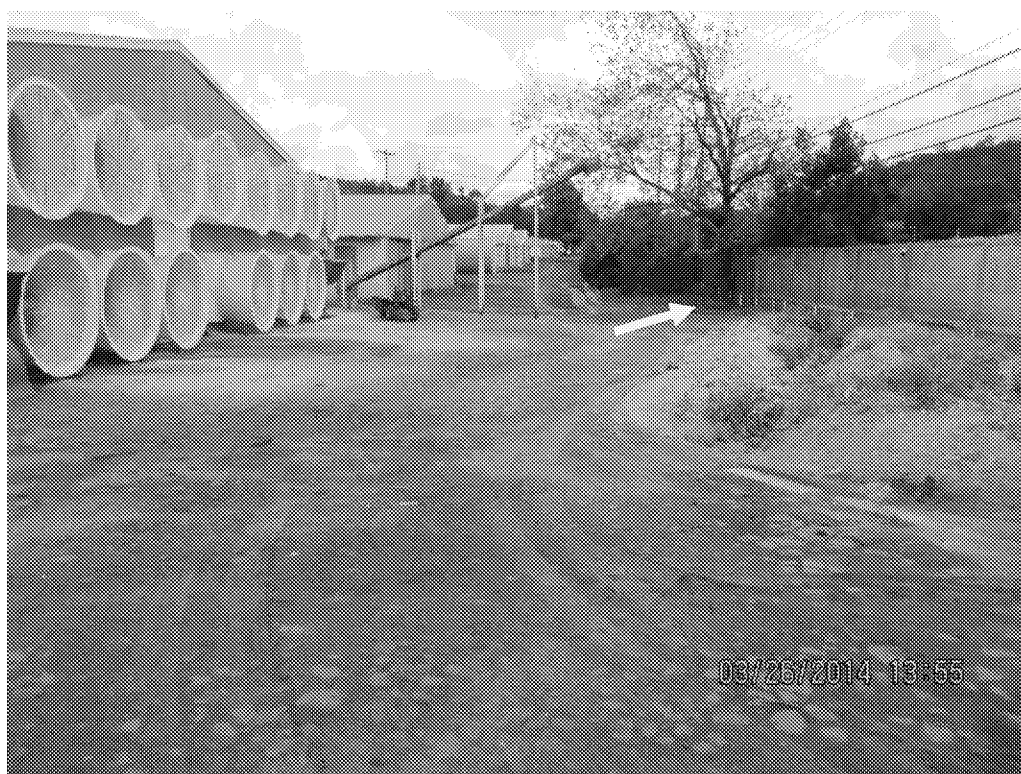
Photo 28 – Blowers airing out the largest hen house, at the NW corner of the facility. The light coloring on the ground is a coating of fine feathers. Discharge point is marked with an arrow.

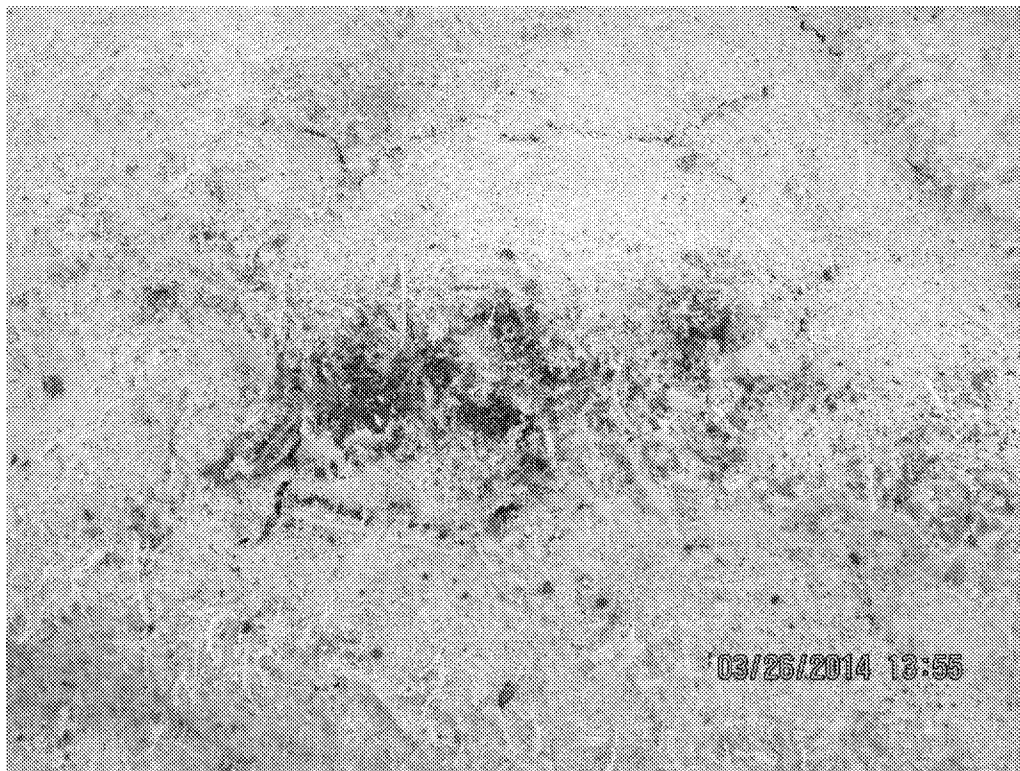
Photo 29 – Feathers coating the ground outside the hen house in the previous photo. Inspector Kristine Karlson kicked the surface of the coating to show the contrast with the darker ground underneath.

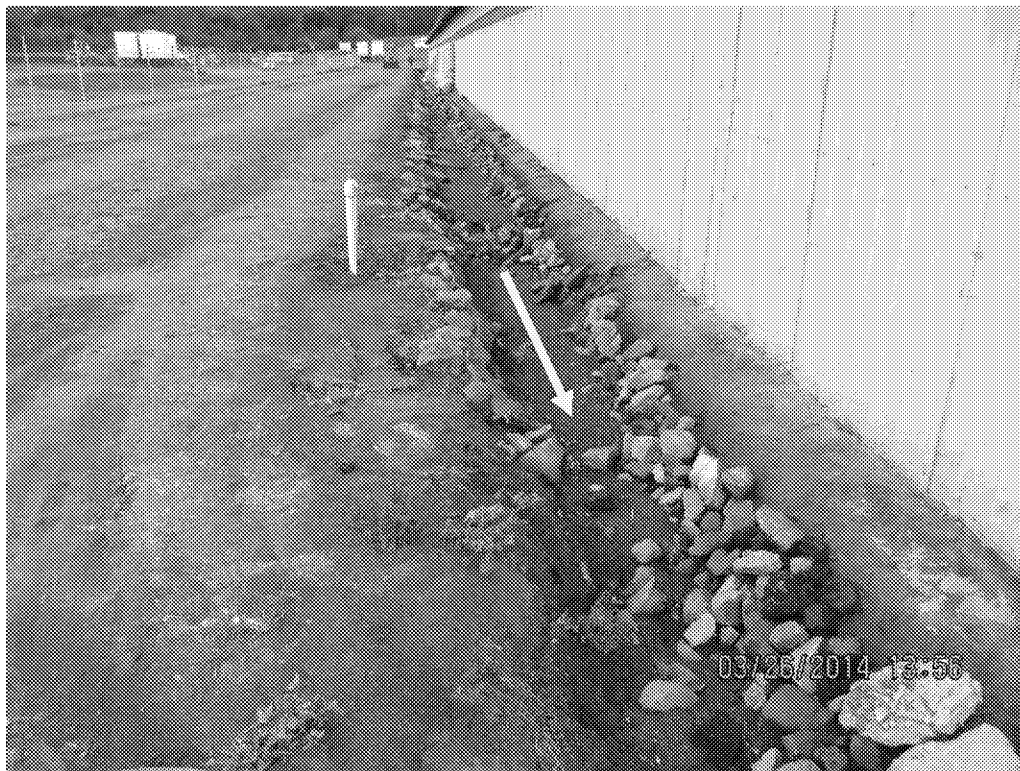
Photo 30 – View to the east of runoff channel alongside the north side of the hen house in Photo 28. Direction of flow, per Mr. Armstrong, is to the west and toward the discharge point (see arrow).

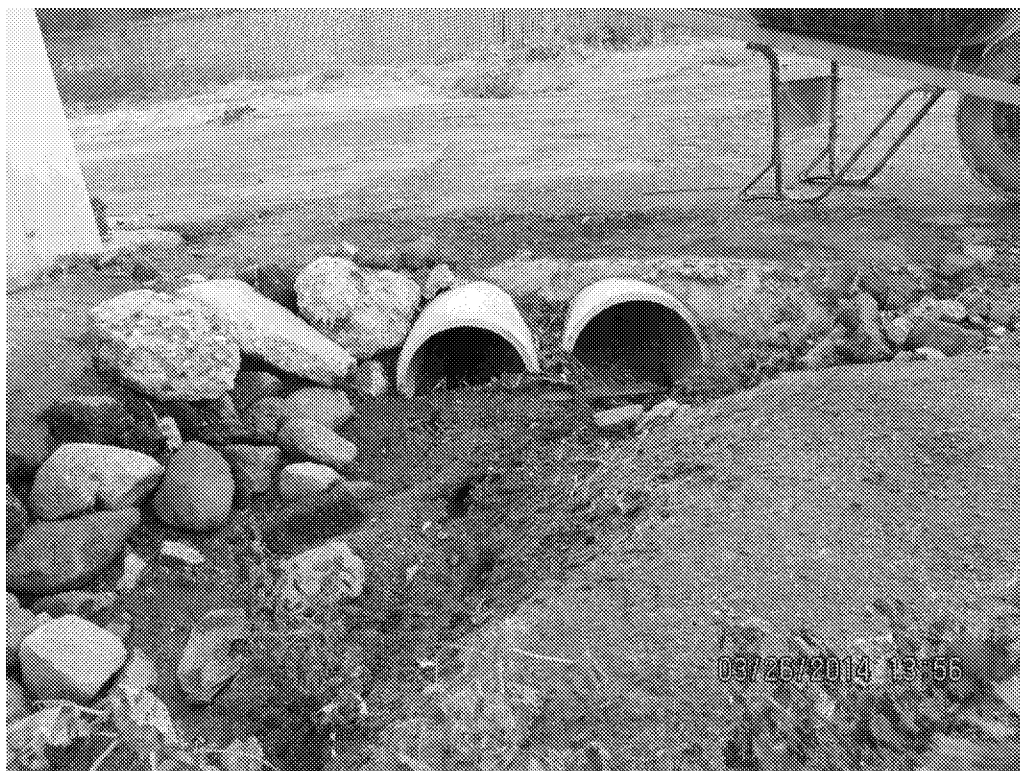
Photo 31 – These pipes convey flows from the channel in the previous photo under the access road along the west side of the facility.

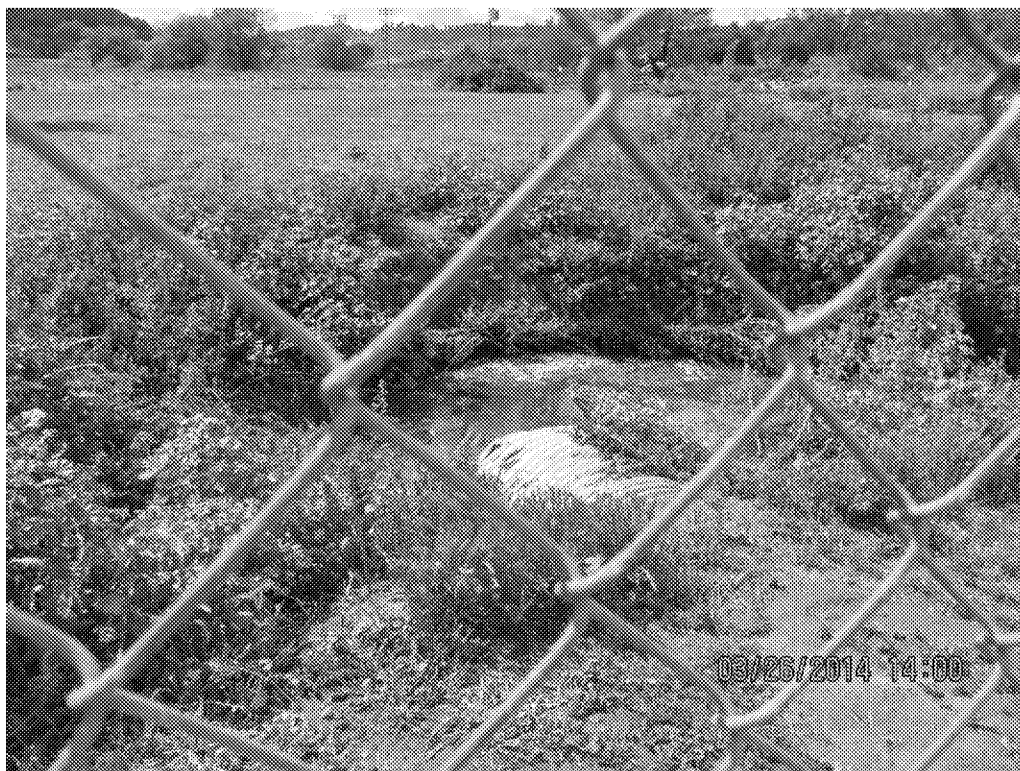
Photo 32 – Outlet of culvert seen in Photo 26. It discharges to the west, into a drainage channel to the west of North Lake Wohlford Rd. Mr. Armstrong said that he leases this property from the owner.
